RUBICON EXPRESS. 3290 MONIER CIR., RANCHO CORDOVA, CA. 95742 916-473-4600

INSTALLATION INSTRUCTIONS FOR: RE8030 2" ZJ BUDGET BOOST SUSPENSION LIFT

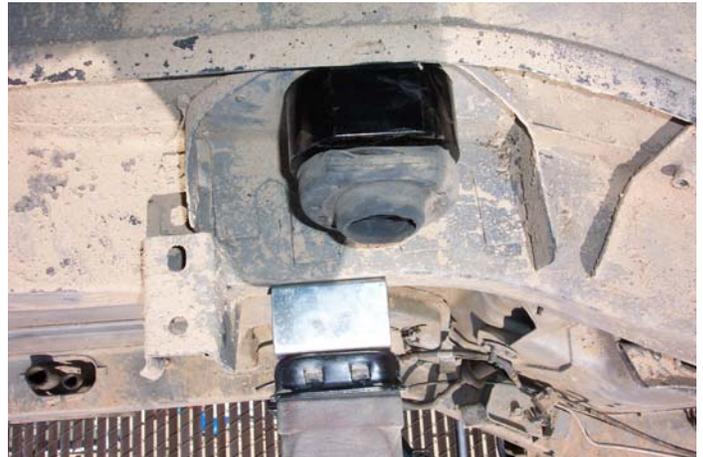
PHOTO 1

1. Support vehicle and remove wheels.
2. Remove old shocks.
3. Disconnect rear sway bar end links.
4. Remove rear factory coils.
5. Remove rear factory rubber coil spring isolators.
6. Install coil spring spacers with raised lip side down (see photo 1). The spacer can be made to nest with the isolator if the isolator is tapered on the top (like front isolator).
7. Install isolator with lip down.
8. Remove the rubber insert from the rear bump stop. Remove the bump stop cup. Place the box steel spacer between the bump stop cup and the frame member of the uni-body using the supplied longer metric hardware. Reinstall rubber bump stop (see photo 2).
9. Install rear coil springs.
10. Reconnect rear sway bar end links.
11. Install new rear shocks.

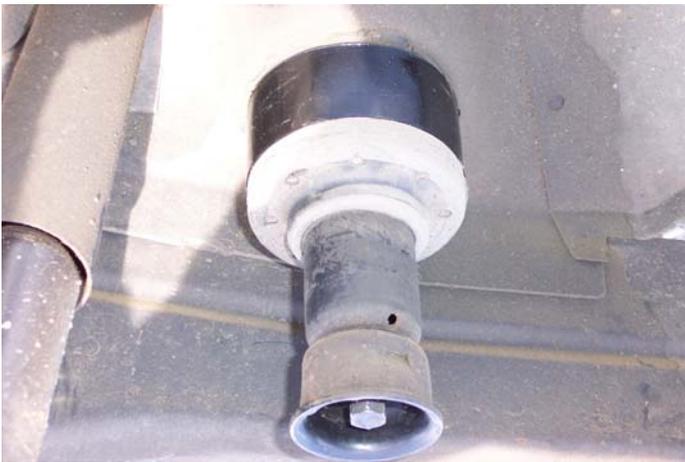
PHOTO 3

14. Remove factory bump stops.
15. Remove rubber coil spring isolators.
16. Install coil spring spacer between frame and rubber spring isolator with lip down (see photo 3). On some models factory bump stop may need to be removed to allow installation of spacer.
